### THERMAL INSPECTION REPORT

# Demo installation (synthetic images)

| Report number | ST-20261015-M8PM-V1 | Version | 1 |

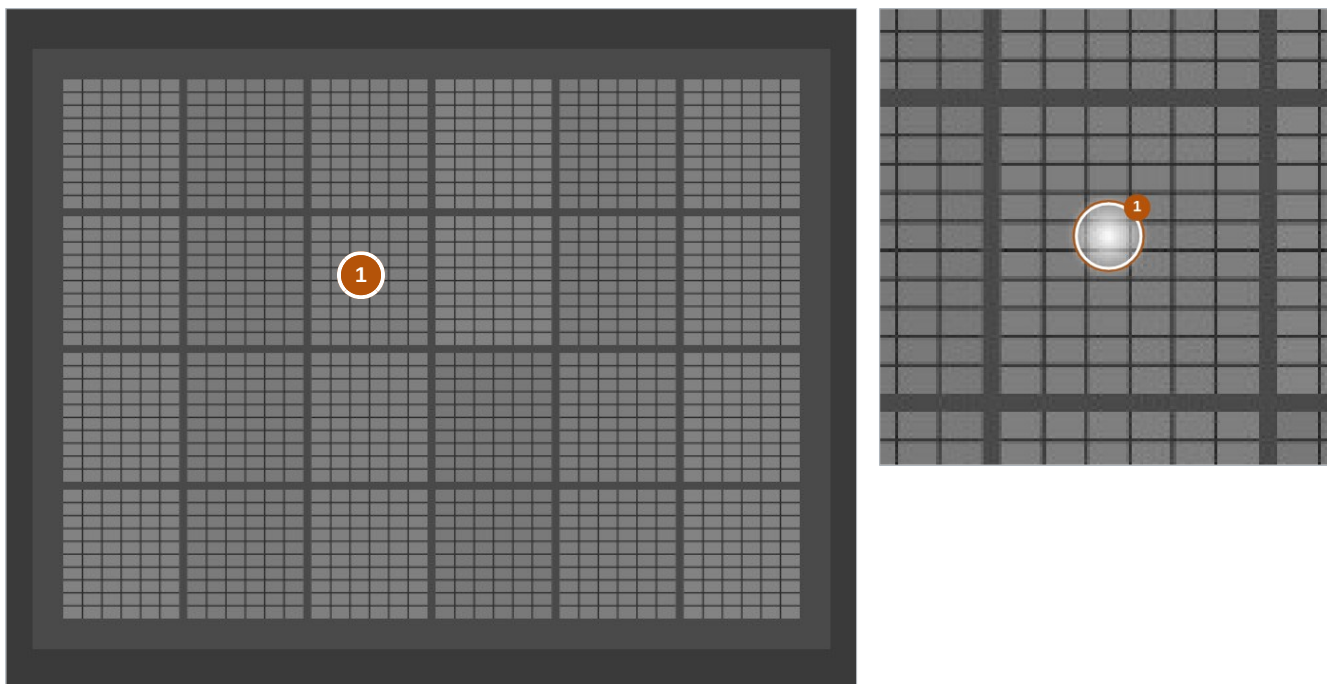
Figure 1: File DEMO\_0001\_T.JPG

### 3.1 Finding 1: Hotspot – single cell

| Observation | Hotspot – single cell | Priority | Medium |
| Cause | Cause unconfirmed | Module/component | Row 2 / Module 3 |

One cell in Row 2 / Module 3 is clearly warmer than the neighbouring cells. Such a pattern can be caused by local soiling or shading, a cracked cell or a cell defect. The thermal image alone does not establish the cause, and a visual check of the module surface has not yet been documented.

At the next visit, check the module surface for soiling, shading and visible damage. If the cell stays warm without an external cause, have the module tested electrically (for example with an I-V curve measurement) by a qualified person.

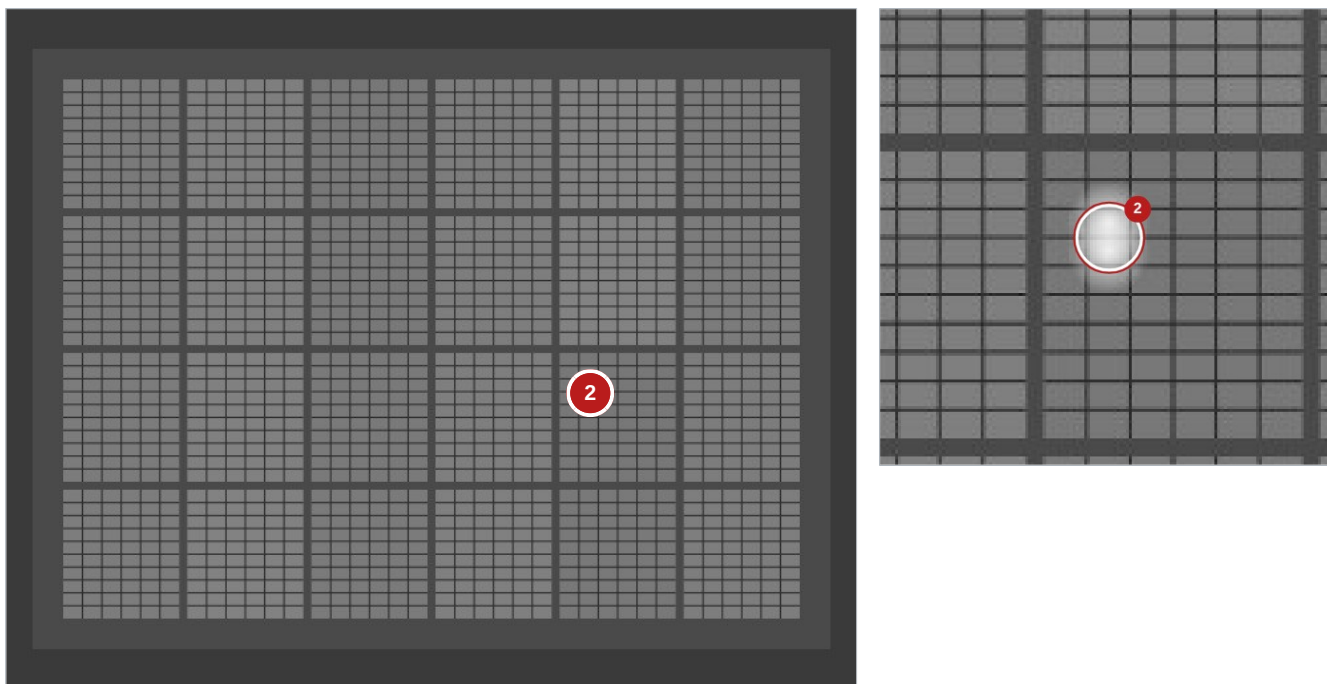
Figure 2: File DEMO\_0002\_T.JPG

### 3.2 Finding 2: Sub-string warmer (bypass diode active)

| Observation | Sub-string warmer (bypass diode active) | Priority | High |
| Cause | Bypass diode – Plausible after visual check | Module/component | Row 3 / Module 5 |

In Row 3 / Module 5, one sub-string section of the module is warmer than the rest of the module. This pattern is consistent with an active bypass diode. According to the author, a defective or permanently conducting bypass diode is plausible after a visual check; it has not been confirmed by an electrical test.

Have the bypass diodes and the junction box of this module checked by a qualified electrician. If a fault is confirmed, replace the diode or the module.
